11 Alarms

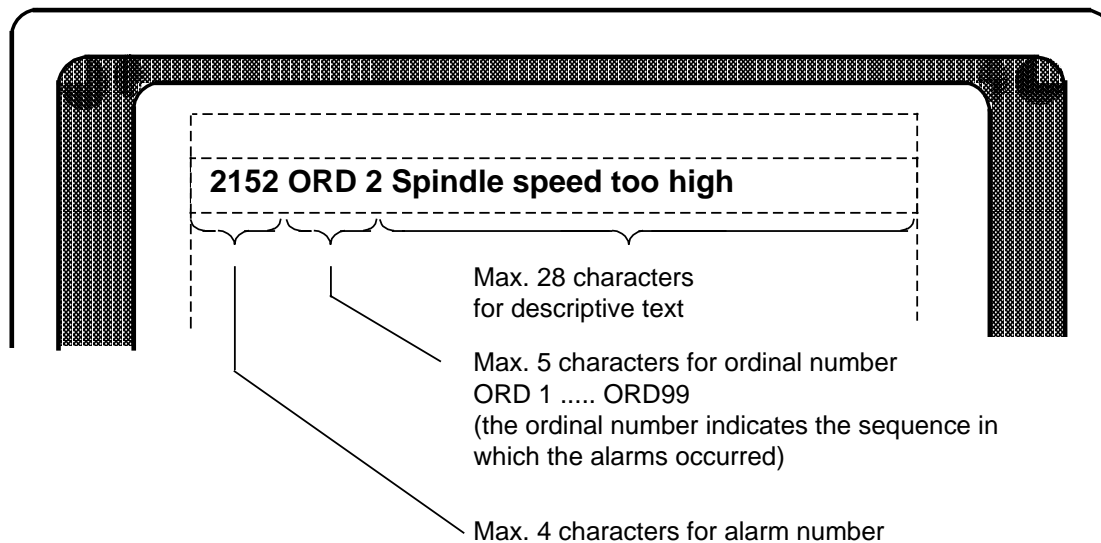
- **Example illustrating display format type A**
Applicable to alarm numbers 0 39 and 2000 2999

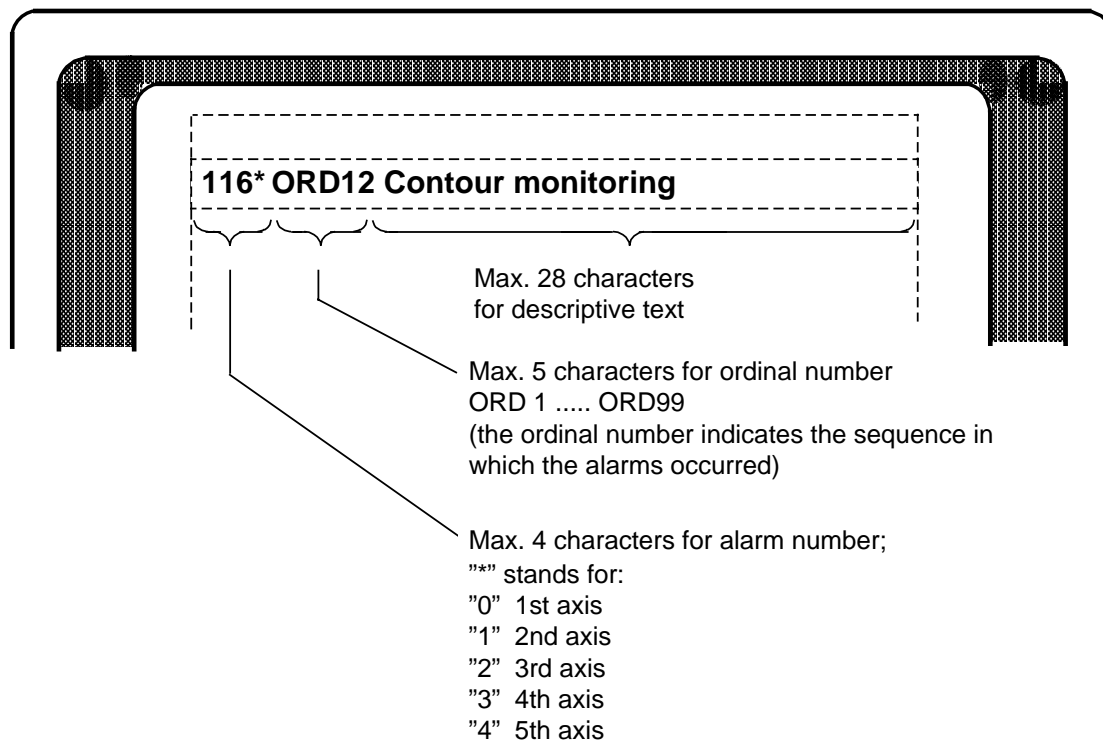
- **Example illustrating display format type B**
Applies to alarm numbers 1000 1963

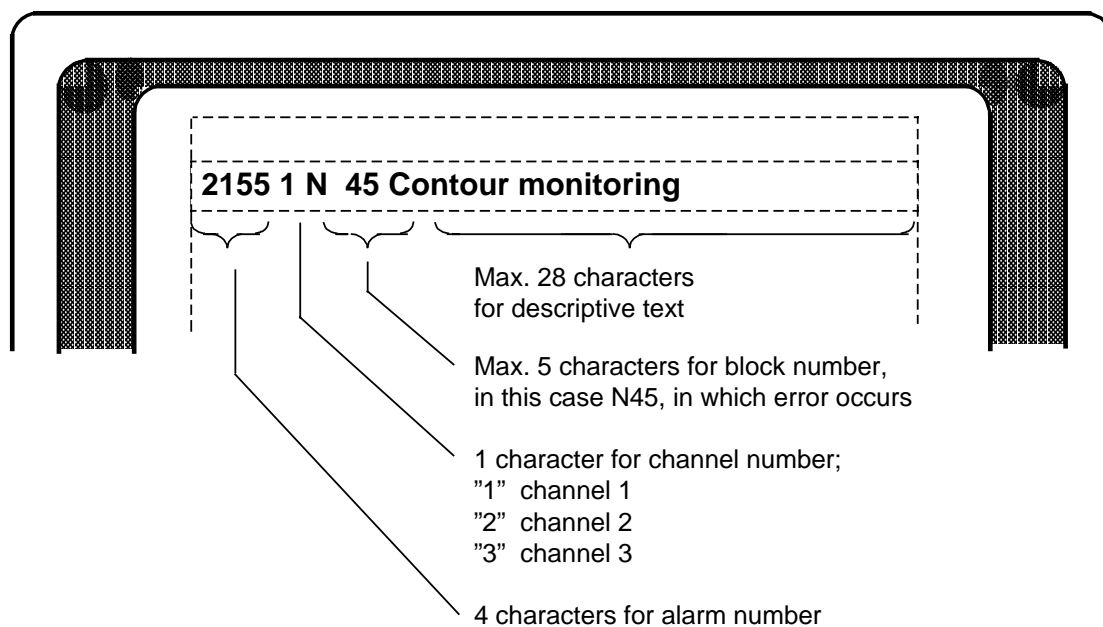
- **Example illustrating display format type C**
Applicable to alarm numbers 2000 2999 (partly) and 3000 3055 (partly)

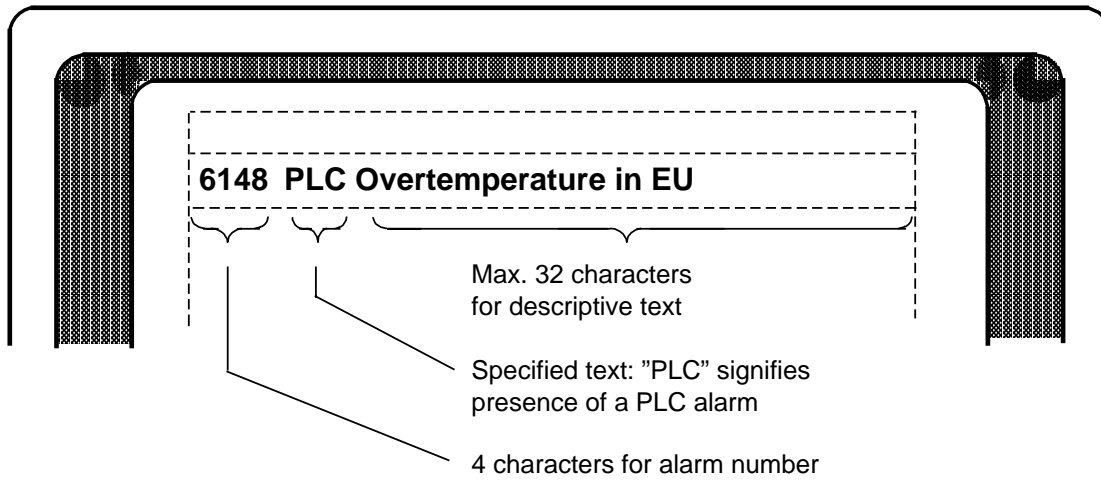
- **Example illustrating display format type D**

**Applicable to alarm numbers 6000 6163 (PLC error messages)
and to alarm numbers 7000 7063 (PLC operational messages)**

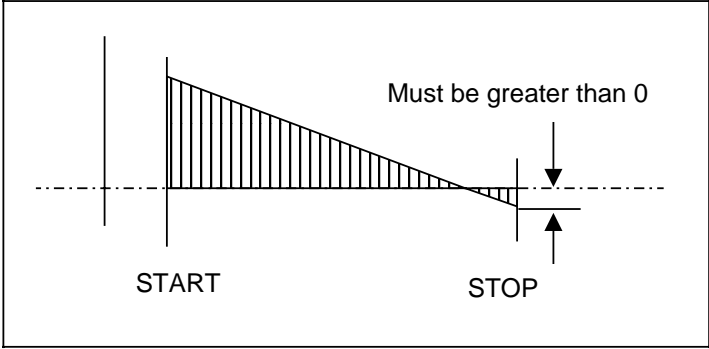
2036	G35 thread lead decr. error
Scan:	During thread cutting.
Significance:	The lead decrease in the thread is so great that a diameter of 0 or less would result at the end of the thread.

Remedy:	Program smaller lead decrease or shorter thread.
